Palace of the Governatorate – Restoration of the arcade and statue of the Virgin Mary

Artist: Giacomo Buzzi Reschini
Date: 1929
Dimensions: 420 x 140 cm
Material: travertine

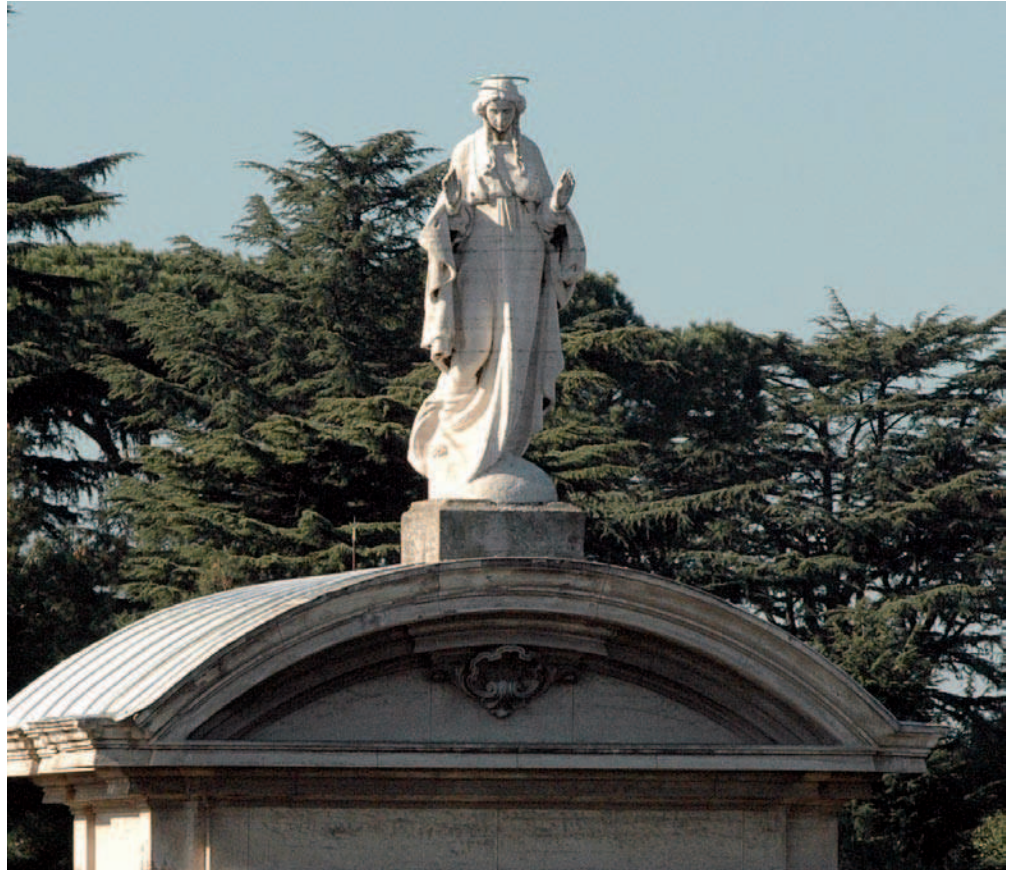
This monument has greatly deteriorated after 80 years of being exposed to the elements. The surface is covered with dust and debris. As photographs show, the edges reveal the metal rebar inside the cement. There are several fissures in the structure as well. Through these cracks, water seeps to the center of the pillars and blocks and weakens the structure. The columns of the arcade have similar issues and damage: scaling of the surface, cracks and rusting of the iron structure.

- Preliminary phase: Accurate diagnosis of actual status of deterioration
- Documentation with laser scanner 3D
- Cleaning of the surface, removal of dark stains
- Removal of previous restorations, integrations and consolidations
- Removal of iron nails from travertine structure and insertion of fibreglass or stainless steel replacements.
- Cleaning and possible substitution of some marble slabs
- Consolidation and fixing of the surface where flaking has occurred
- Application of glazing to achieve chromatic balance
- Final photographic documentation

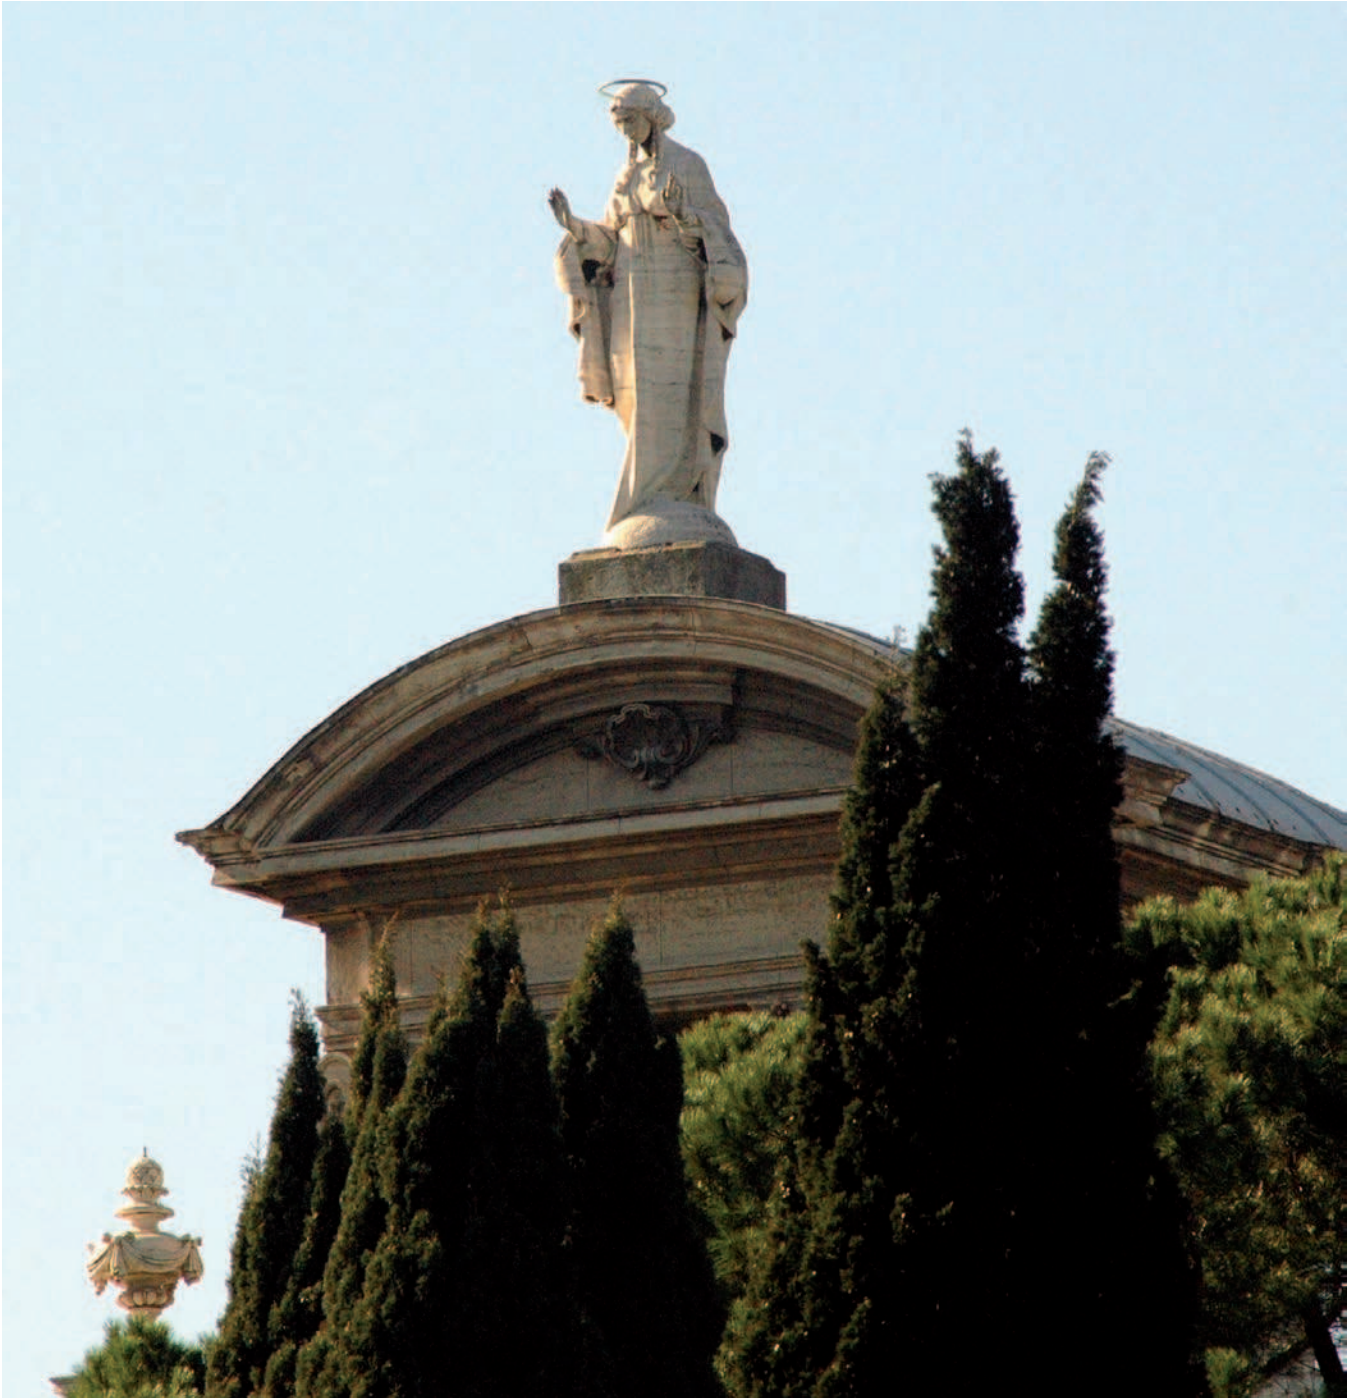
A beautiful travertine statue of the Virgin Mary stands atop the structure and oversees those who pass some 70 feet below her. She was sculpted by Giacomo Buzzi Reschini, who placed her below an arched roof resting on a series of columns. This statue is clearly visible from the Vatican Gardens and to the many pilgrims who climb to the top of the cupola of St. Peter's. This impressive statue and the portico that houses it are in need of repair. The earthquakes in Aquila prompted a general revision of the structure. This was when the deterioration and structural weakening was noticed and brought to the attention of the Patrons Office.

The Virgin watches over the Vatican Gardens and the Governatorate
